Manhole Inspection Summary

Manhole # S47C__007MH

Insp Date: **7/14/08 12:44 PM**

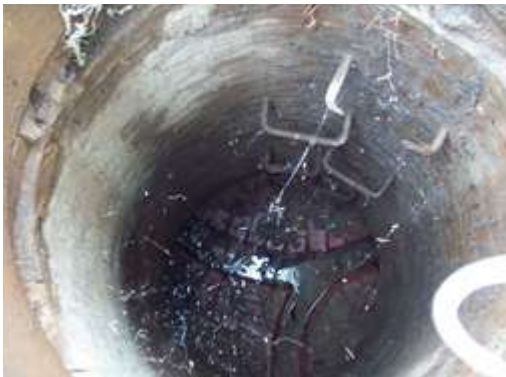
Defect 2

Steps Count: **5** Missing: **1** ☒ **Corroded**

missing steps

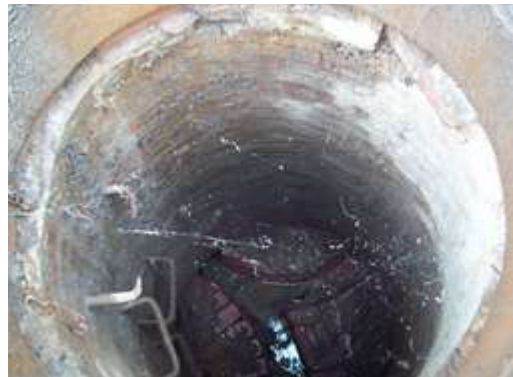
Defect 1

Condition: ☐ Sound ☐ Cracked ☐ Root Intrusion ☒ **Loose Brick** ☐ Deteriorated

Infiltration: ☐ None ☐ Joint ☐ Cracks ☒ **Mortar** ☐ Roots ☐ Wall

loose brick

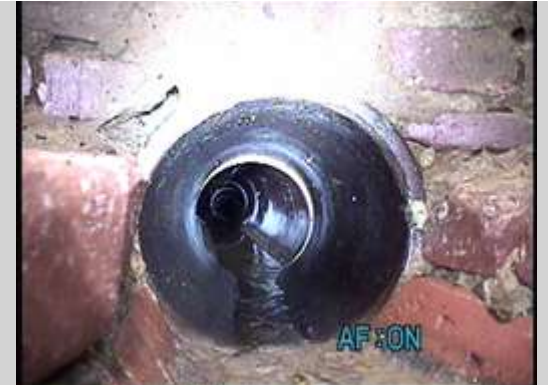
12 O'Clock Outflow

Pipe Height: **8.4** (in.) Rod and Bar (Angled)
Pipe Material: **Clay** ☐ Pipe Lined
Invert Depth: **10.45** (ft.) Flow Characteristics: **Slow**
Deposits: ☒ None ☐ Mud ☐ Sludge ☐ Debris ☐ Grease
Silt Depth: (in.) Deposits Extent:
Infiltration: **None** Pipe Seal Cond: **Sound**

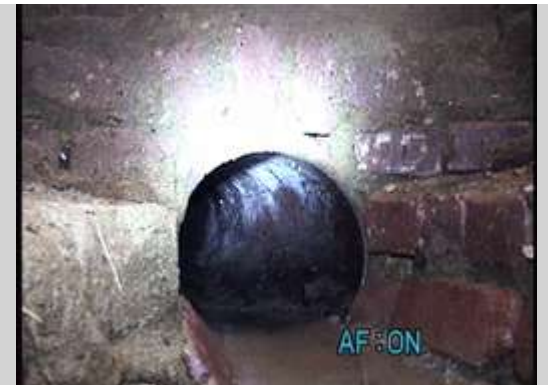
3 O'Clock Inflow

Pipe Height: **8.4** (in.) Rod and Bar (Angled)
Pipe Material: **Clay** ☐ Pipe Lined
Invert Depth: **10.40** (ft.) Flow Characteristics: **Slow**
Deposits: ☒ None ☐ Mud ☐ Sludge ☐ Debris ☐ Grease
Silt Depth: (in.) Deposits Extent:
Infiltration: **None** Pipe Seal Cond: **Sound**

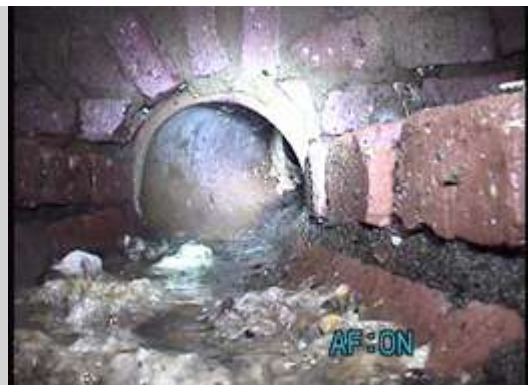
7 O'Clock Inflow

Pipe Height: **8.4** (in.) Rod and Bar (Angled)

Infiltration: **None**

Pipe Seal Cond: **Sound**
